Overheating of the control unit ECU

CODE: 2.43109 - 2.43100

APPLICATIONS: OPEL / Astra 1 7 DTI / 09/2000 - 01/2004 / Y 17 DT

OE: OPEL - 06237108, 097189136

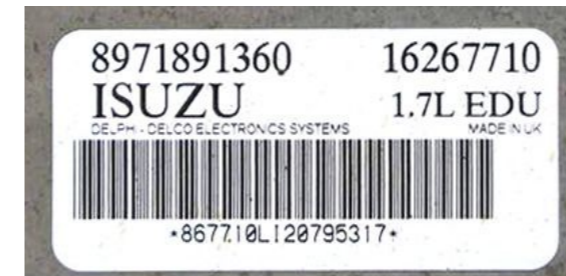
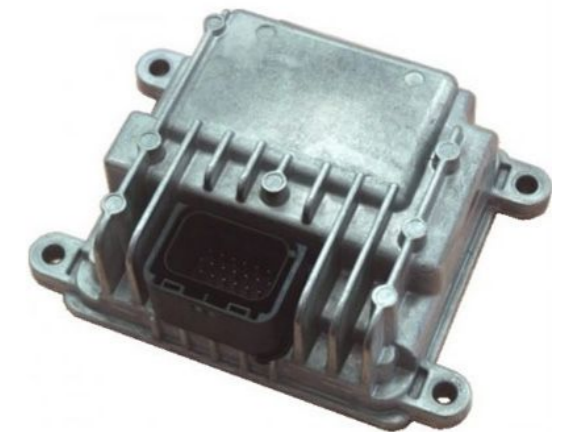
La centralina ISUZU è montata sul motore, ed è soggetta ad elevate temperature che con il tempo, come si può notare in figura, fanno surriscaldare le saldature della pista interna.

Come conseguenza del calore e delle vibrazioni la centralina ogni 4 mesi circa cessa di funzionare mandando in avaria il motore e la gestione della pompa di iniezione. A livello pratico si danneggiano le saldature dei circuiti interni.

Causa del guasto è la vicinanza della centralina al motore ed ai suoi componenti. Per risolvere il problema, la centralina deve essere spostata in una posizione idonea, meno esposta alle fonti di calore eccessive.

Come esempi per l'installazione si possono citare: la zona del misuratore massa aria verso la carrozzeria, oppure vicino al motorino tergi (ma si corre il rischio che a lungo termine l'acqua possa diventare un problema).

La centralina ha bisogno di ricircolo di aria per raffreddarsi.

NOTA: Per poterla spostare è necessario allungare il cablaggio.

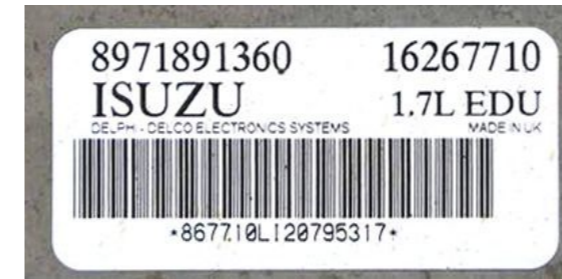
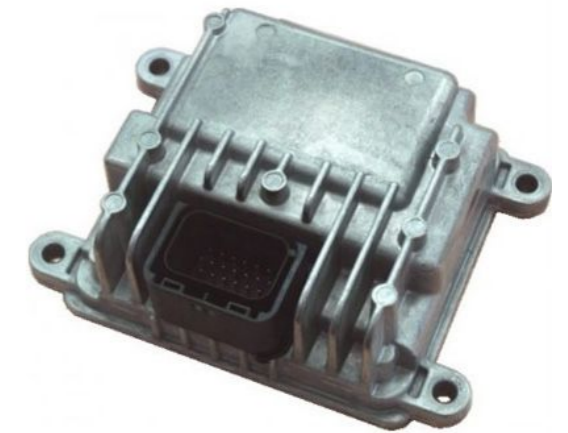
The ISUZU control unit is subjected to high temperatures on the engine and after a while this can cause the weldings overheating of the internal pcb (see picture).

As a consequence of the heating and vibrations, the control unit stops working in about 4 months and provokes the damage of the engine and of the injection pump (the weldings of the internal circuit get damaged).

The reason of the damage has to be found in the position of the control unit, too close to the engine and to its components. To solve the issue, the control unit should be placed in a better position, less exposed to high temperatures.

As an example for the installation we could move the ECU towards the mass airflowmeter next to the car body or near the wiper engine (but in a long term water might cause problems).

The control unit needs air recirculation for the cooling.

WARNING: it is necessary to extend the wiring in order to move the control unit.
