EGR VALVE SCUDO

Fiat Auto Service News

Information 10.30.10 del 08/02/2012

272- SCUDO 2.0 16V JTDT.T. Injection control unit - EGR electrovalve

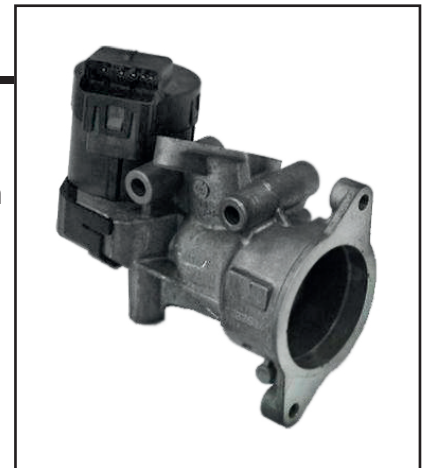
Dall'info del **Servizio di Assistenza Fiat** sotto si comprende bene che la rottura del piattello della valvola EGR non è da imputare ad un difetto di fabbricazione della stessa, (stelo troppo sottile o saldatura eseguita male) ma questa rottura è dovuta a cause esterne che nulla hanno a che fare con il prodotto da noi venduto.

From FIAT's Servizio di Assistenza information below, it is clear that a plate breakage of the EGR valve is not due to a manufacturing defect of the same, (stem too thin or welding performed poorly), but due to external causes that have nothing to do with the product we provide.

Rupture of the EGR valve: in some cases, the plate of the valve, which is controlled to excessive speed by the control unit, is repeatedly beaten on its base eventually breaking away from the rod.

Al momento della vendita informare il cliente che oltre alla sostituzione del EGR vi è la necessità assoluta di aggiornare la centralina onde evitare di incorrere nello stesso difetto.

At the time of sale let the customer know that in addition to the replacement of the EGR there is an absolute need to update the Control unit in order to avoid incurring the same defect.

In the presence of complains and found fault replace the EGR valve and reprogram the injection control unit with the new software WEB Flash 8.20.5 (or higher) available from ExaminerWeb and wiTEXEDi.
